Otto Focus  
Research Scientist  
Corporation ABC  
123 Industry Road  
Austenite, MN 12345

Report Date: April 1, 2015  
Date Submitted: April 1, 2015  
MEE Project: ZZ0001  
Sample ID: 12345  
P.O. No.: 54321

**PROJECT TITLE:** Evaluation of a Failed Right Lateral Water Wall Tube

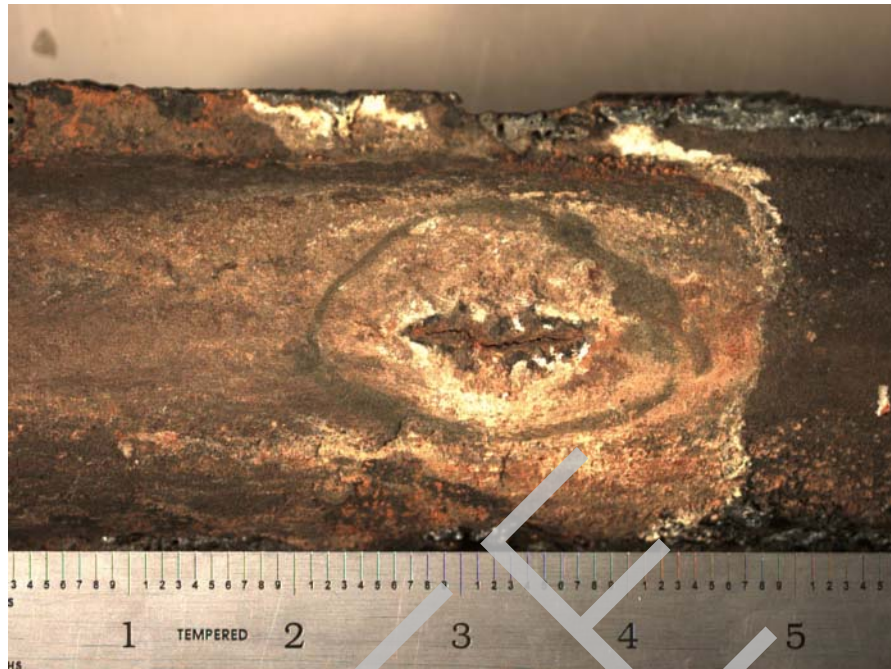
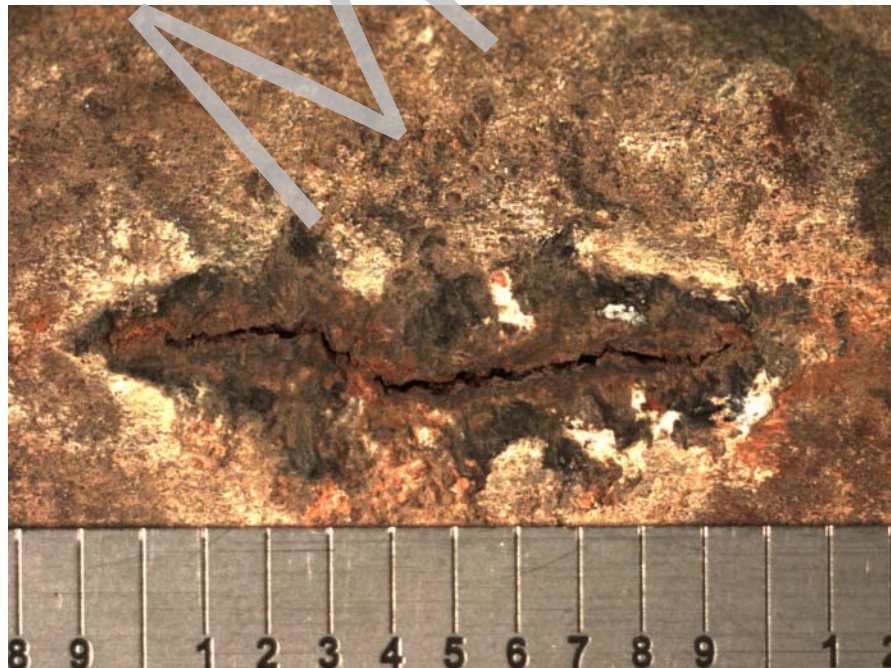
A 11-in. long section of a right lateral water wall tube was submitted. The outer surface of one side of the tube had a slightly rough texture and a thin light brown scale, Figure 1. This was assumed to be the hot side of the tube. There was an approximately 1-in. long longitudinal crack near the center of the section on the hot side of the tube, Figure 2.

Figure 2 Crack on the outer surface of the hot side of the tube.

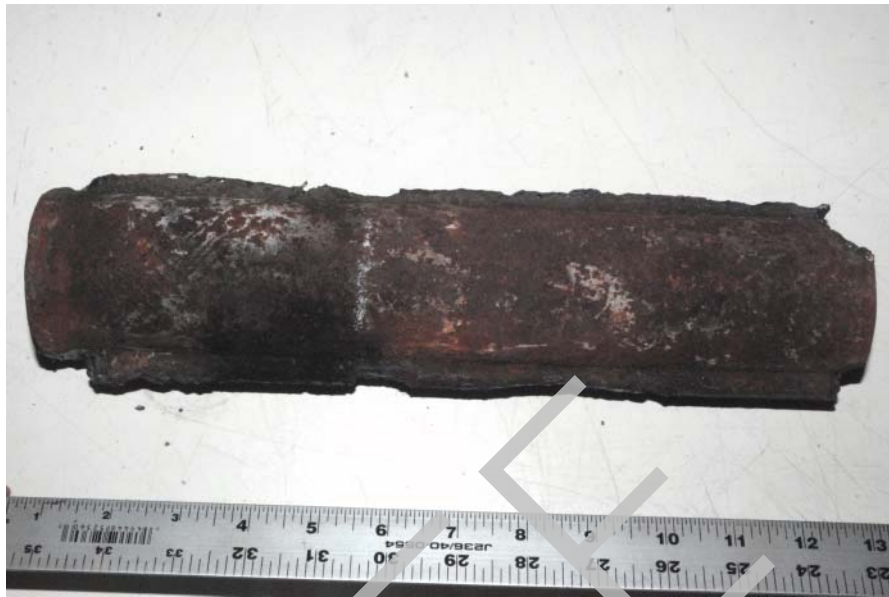
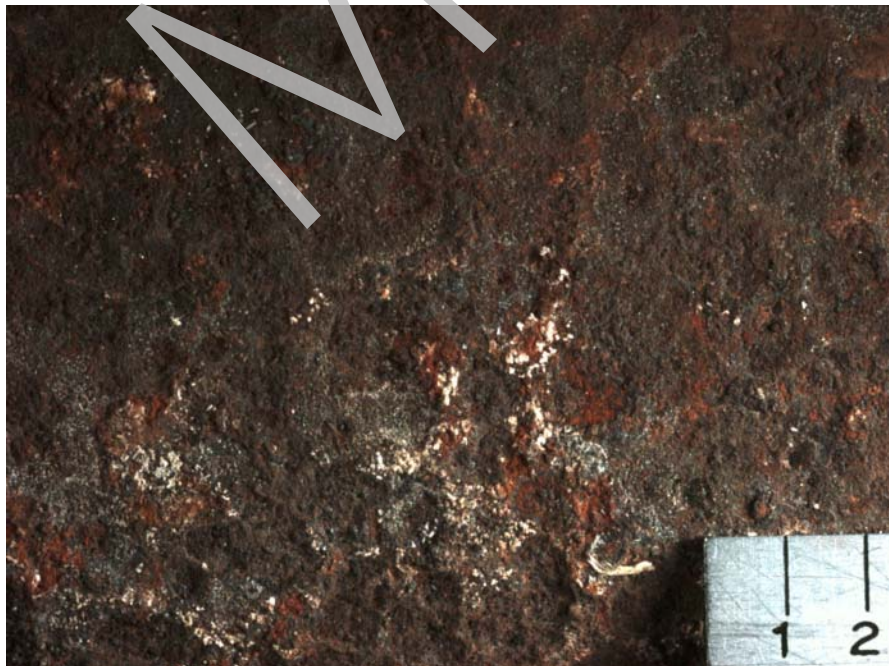
The cold side of the tube was a dark red-brown color and had numerous small pits on the outer surface, Figure 3.

Figure 3 Cold side of the as-received tube.

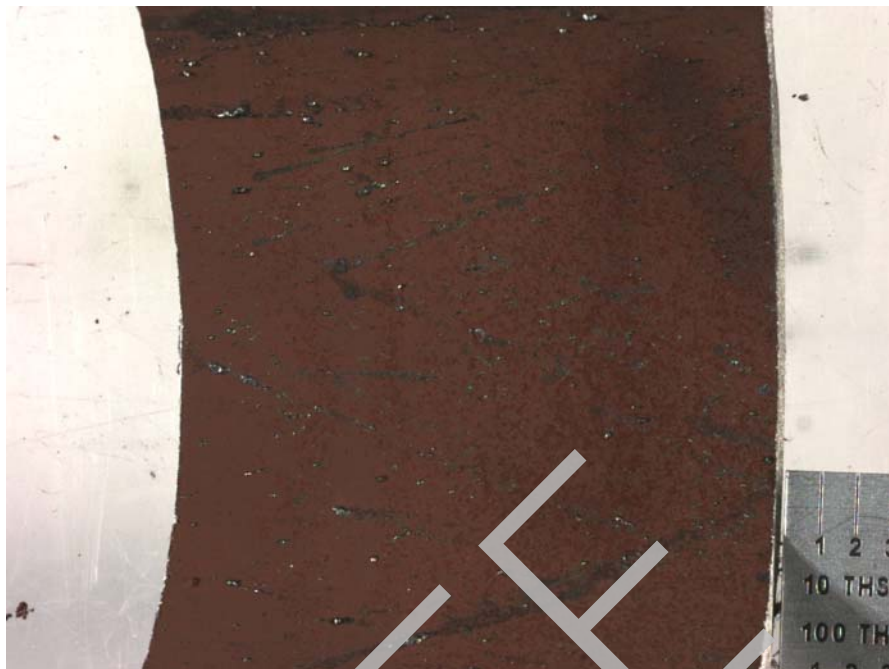
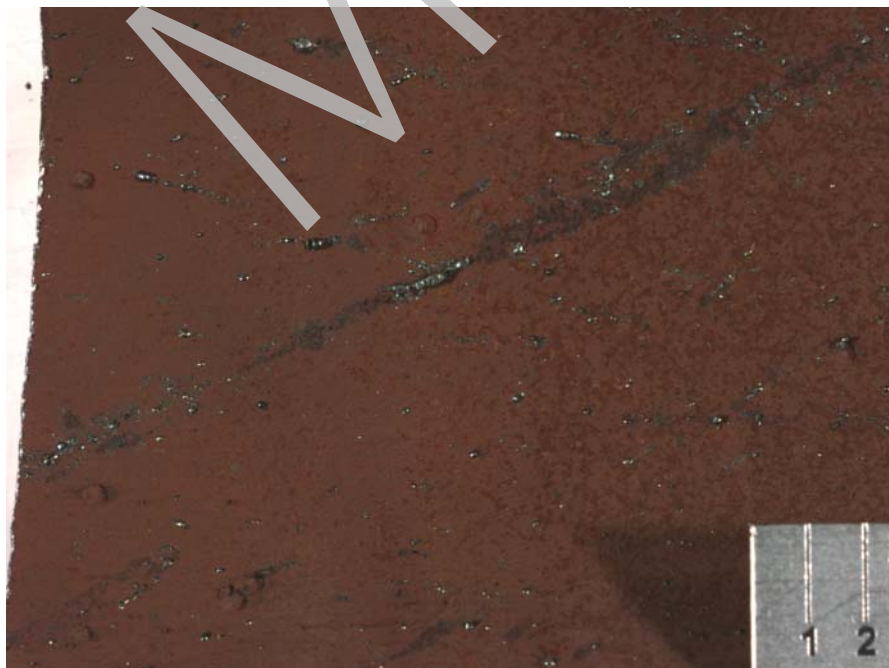
The inner surface of the tube was entirely covered with adherent dark-red deposits. On the cold side of the tube, the deposits were relatively thin and smooth, Figure 4. On the hot side, the deposits were considerably thicker and had a flaky texture, Figure 5. The outline of the crack on the inside surface was not easily distinguishable under the thick deposits and scale.

Figure 4 Deposits on the inner surface of the cold side of the tube.

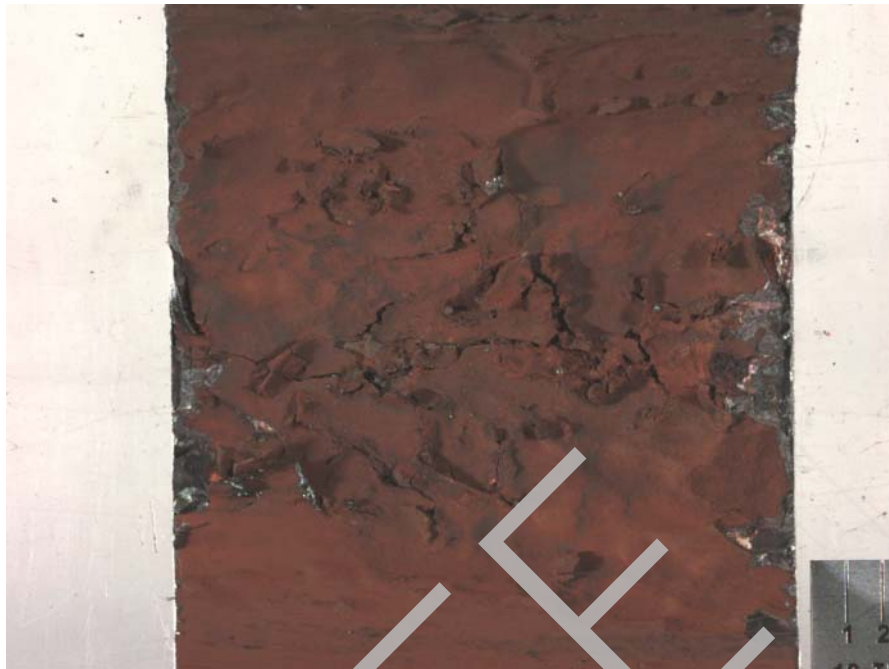
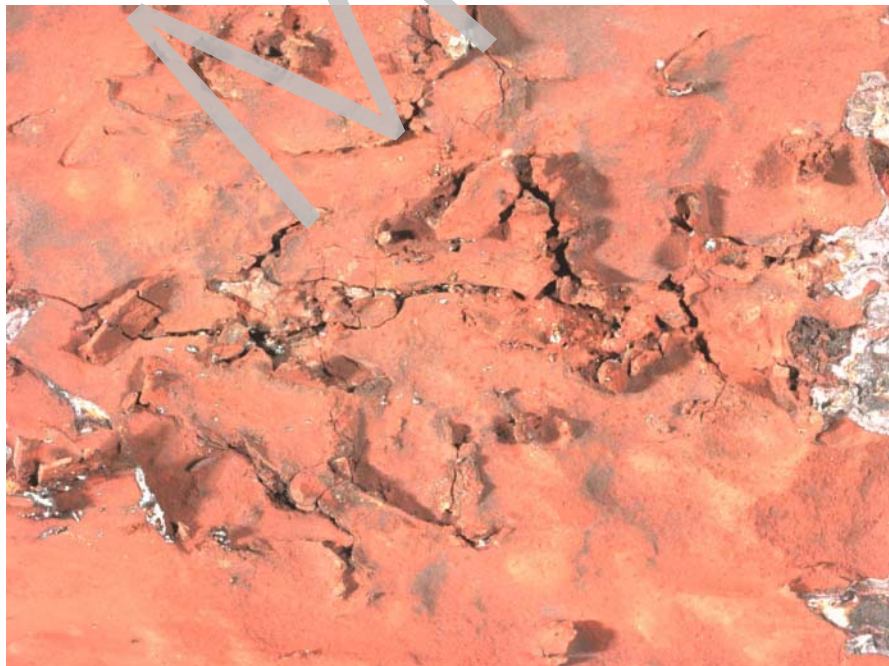
Figure 5 Deposits and cracking on the inner surface of the hot side of the tube.

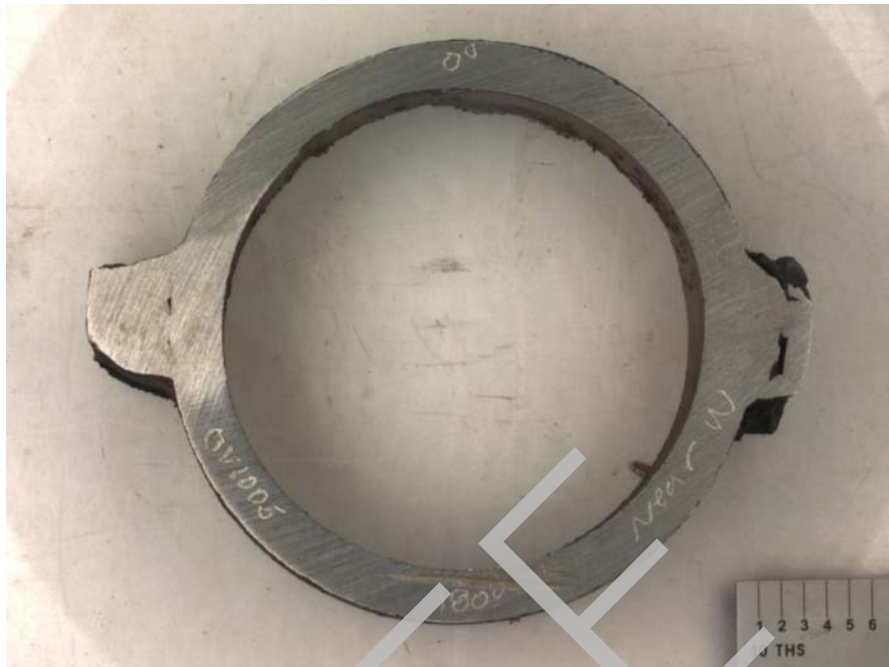
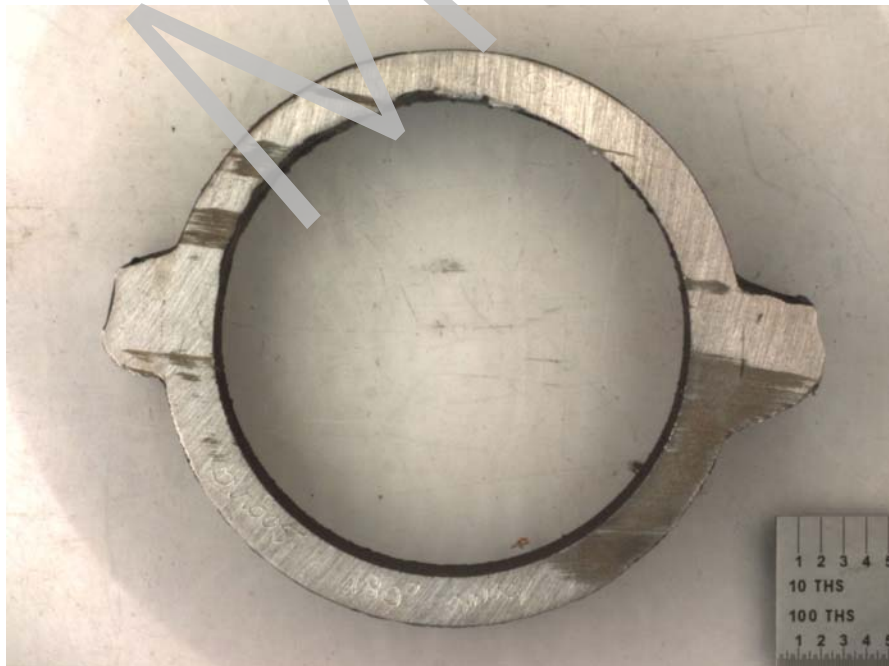
Location	Wall Thickness, in.	
	Measured	Average
Near crack - hot side	0.163, 0.187, 0.182	0.177
Near crack - cold side	0.223, 0.222, 0.226	0.224
Away from crack - hot side	0.193, 0.190, 0.207	0.197
Away from crack - cold side	0.221, 0.220, 0.218	0.22

Figure 6 Rings removed from the indicated location for wall thickness measurements. The hot side is at the top of the ring in both images.

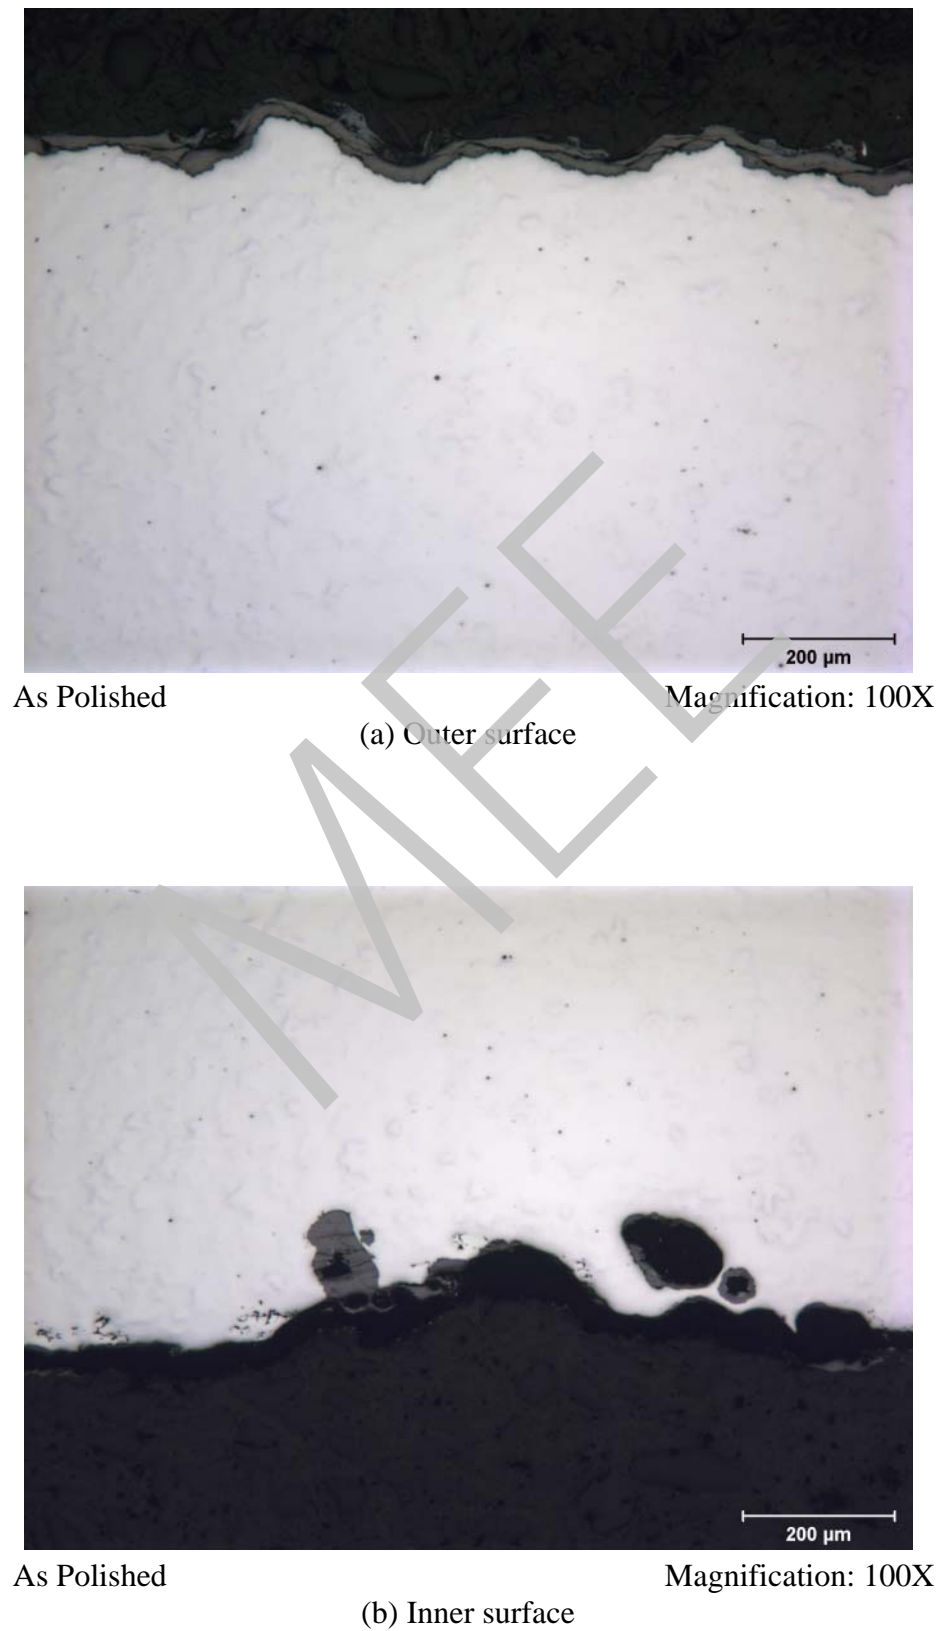
Cold side - The outer surface was relatively smooth with a few shallow pits and a thin nonmetallic scale, Figure 7a. The inner surface had a few localized regions of deeper pits, Figure 7b. Some of the pits were filled with nonmetallic deposits and scale.

Figure 7 Cross section at the indicated surfaces on the cold side of the tube.

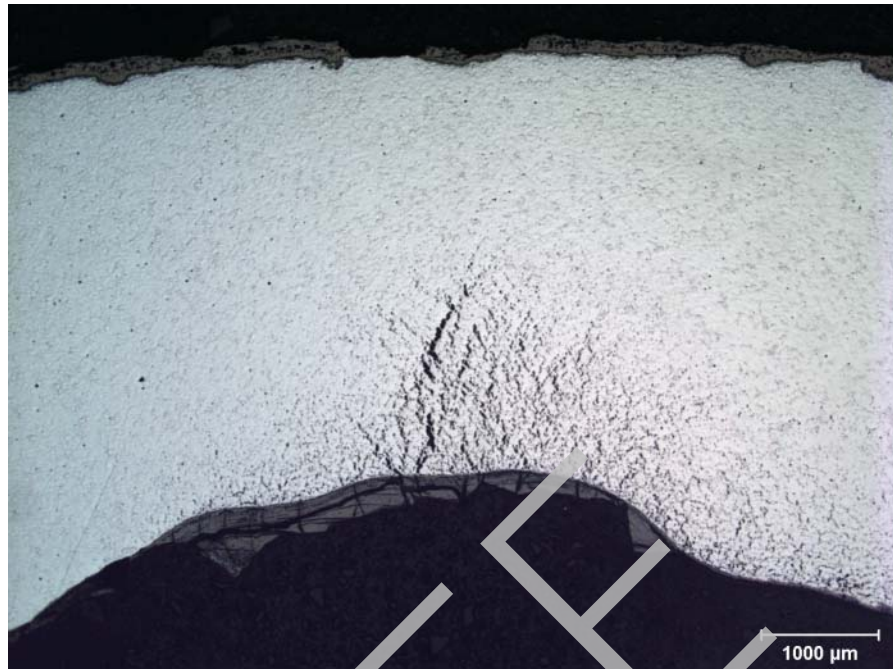
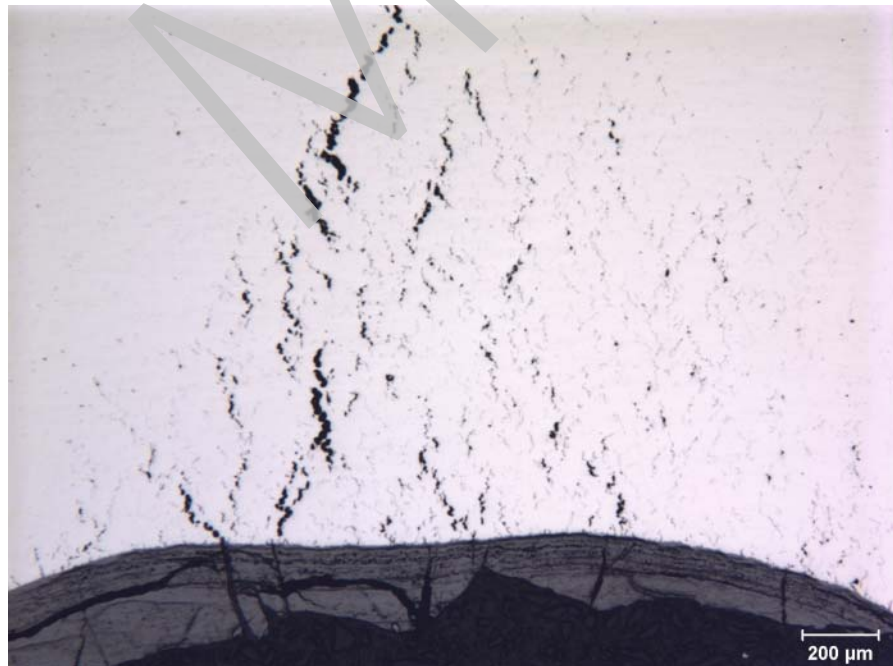
A metallographically-prepared cross section of the tube revealed numerous tight cracks in the tube wall near the inside surface on the hot side of the tube. The cracking was discontinuous and followed the material grain boundaries. The cracks were more concentrated and penetrated further into the wall thickness near a large pit. Intergranular cracks within the wall were consistent with a fracture mechanism of hydrogen damage.

The intergranular cracking pattern under thick deposits and the numerous cracks within the wall thickness indicated that the tube failed due to hydrogen damage. Failures due to hydrogen damage are commonly caused by either a high or low pH excursion on the water side of the tube. Chemical reactions between a metal and acid or caustic conditions can liberate atomic hydrogen, which diffuses into the steel. In the steel, the hydrogen reacts to form small cracks on the grain boundaries, which eventually coalesce to form a leak through the tube wall.

Hot side - The outer surface had a few shallow pits and a moderately-thick nonmetallic scale,

Figure 8a. The inner surface had a larger, much deeper pit filled with nonmetallic deposits and scale.

There were numerous small, tight cracks in the tube wall near the inner surface of the tube, Figure 8. The highest concentration and deepest penetration of the cracks was located at the large pit. The cracks were discontinuous and followed the contours of the grain boundaries. In some areas, the small cracks had coalesced to form larger cracks, Figures 8 and 9.

Figure 8 Cross section showing cracks in the hot side of the tube.

Most commonly, variations in pH are caused by contamination due to either condenser in-leakage or water contaminants. Preventing contamination, condenser in-leakage, and excessive water-side deposition and scale formation are the most effective ways of preventing hydrogen damage. Periodic tube sampling to is recommended to monitor these conditions.

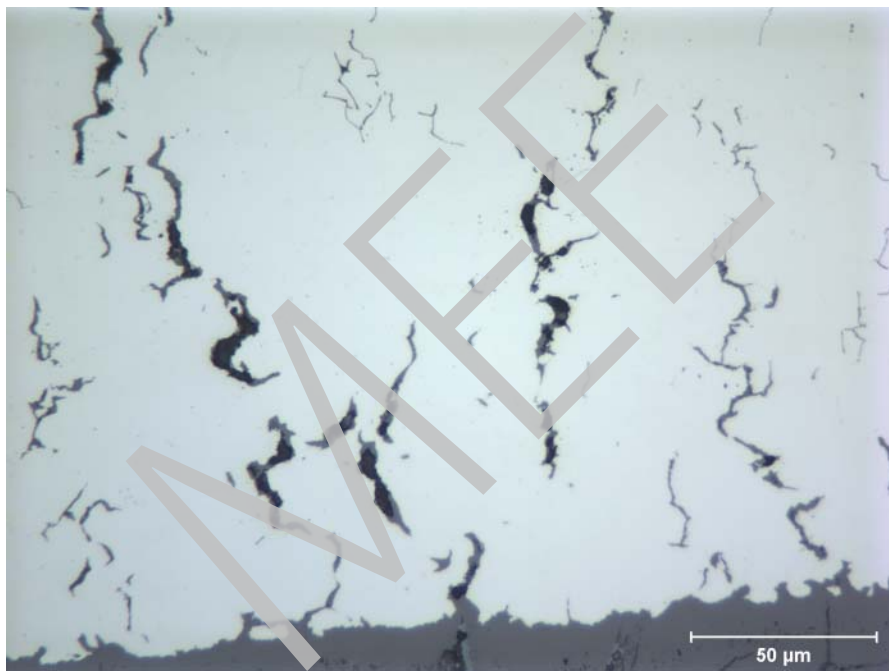
Figure 9 Cracks near the inside surface on the hot side of the tube.

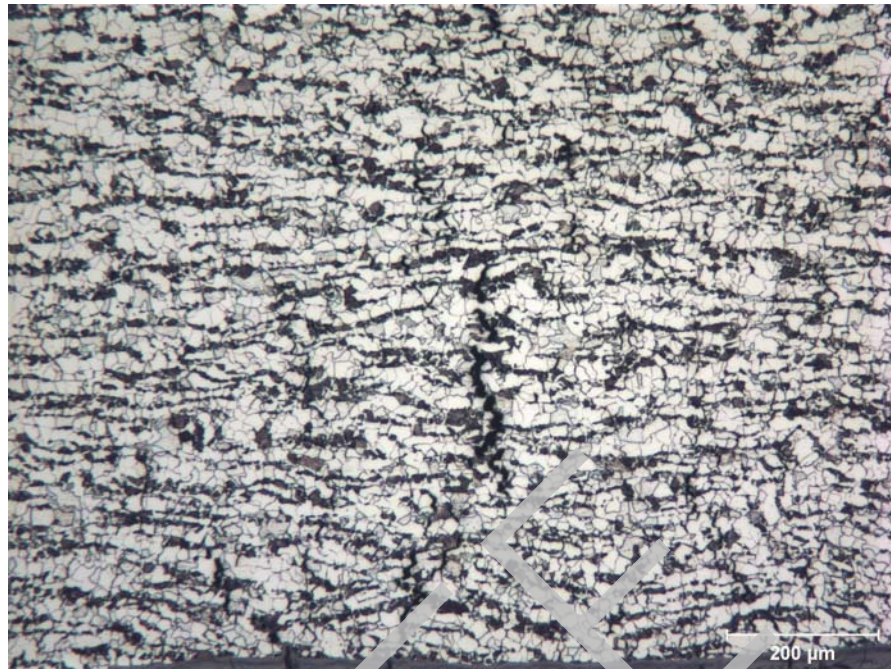
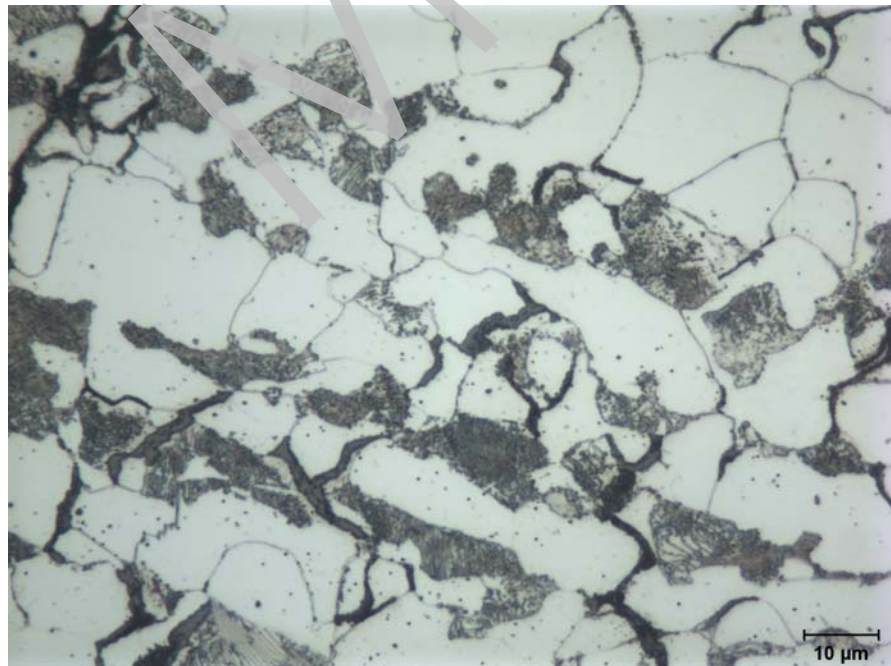
The microstructure of the tube metal consisted of a ferrite matrix with narrow bands of small pearlite islands, Figures 10 and 11. This structure was consistent with a carbon steel tube in the normalized condition.

Figure 10 Microstructure of the tube metal on the hot side of the tube.

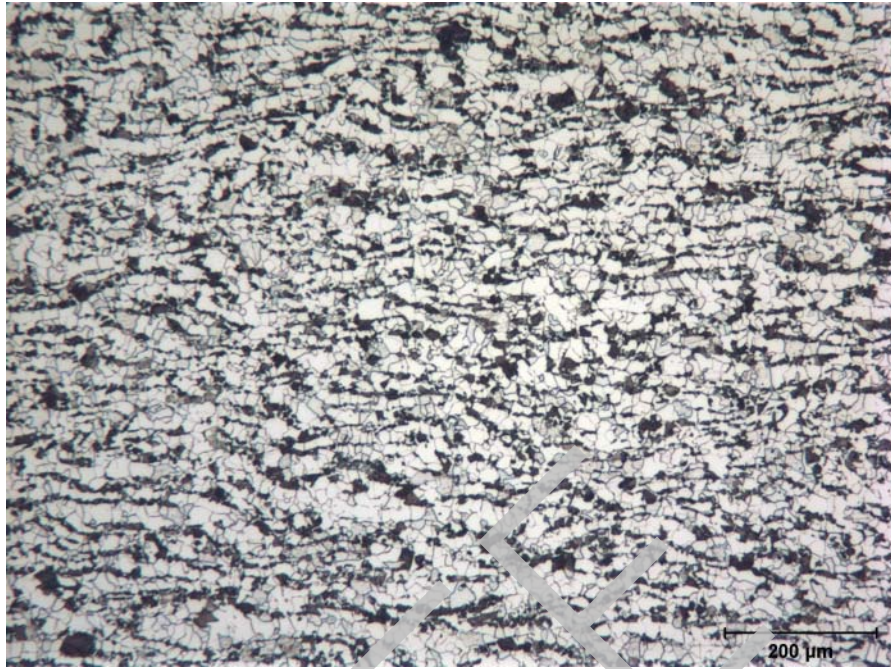
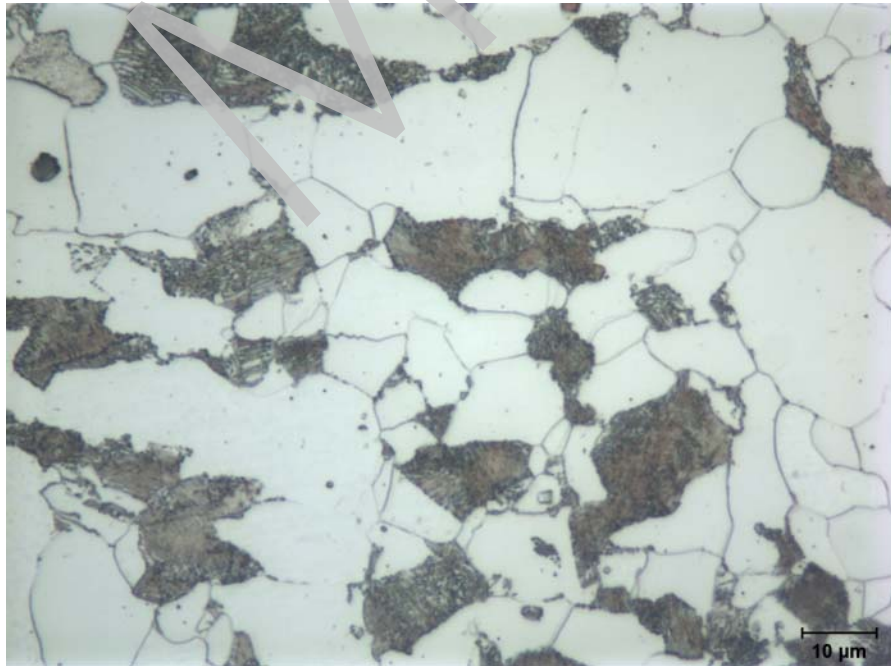
Figure 11 Mmicrostructure of the tube metal on the cold side of the tube.

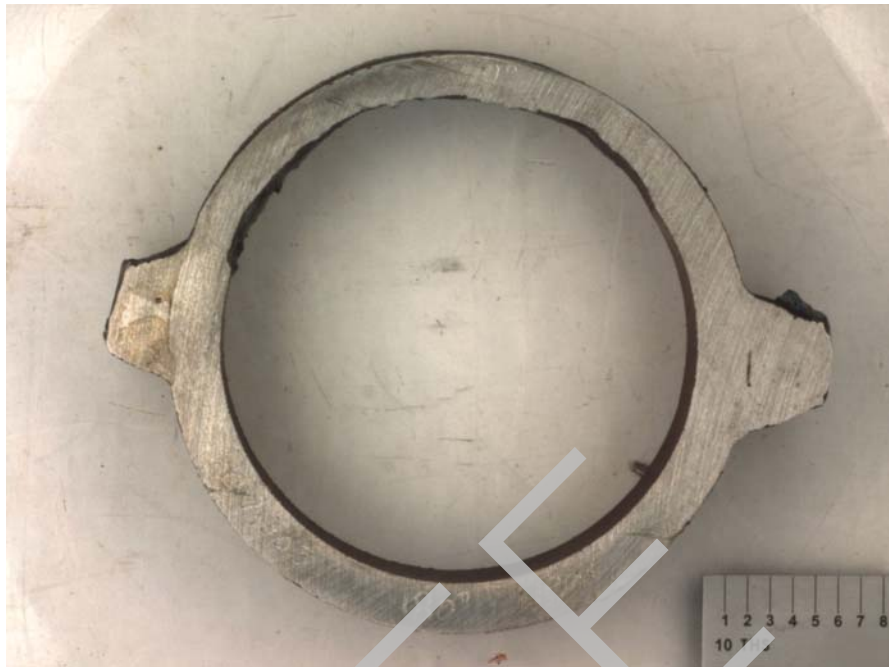
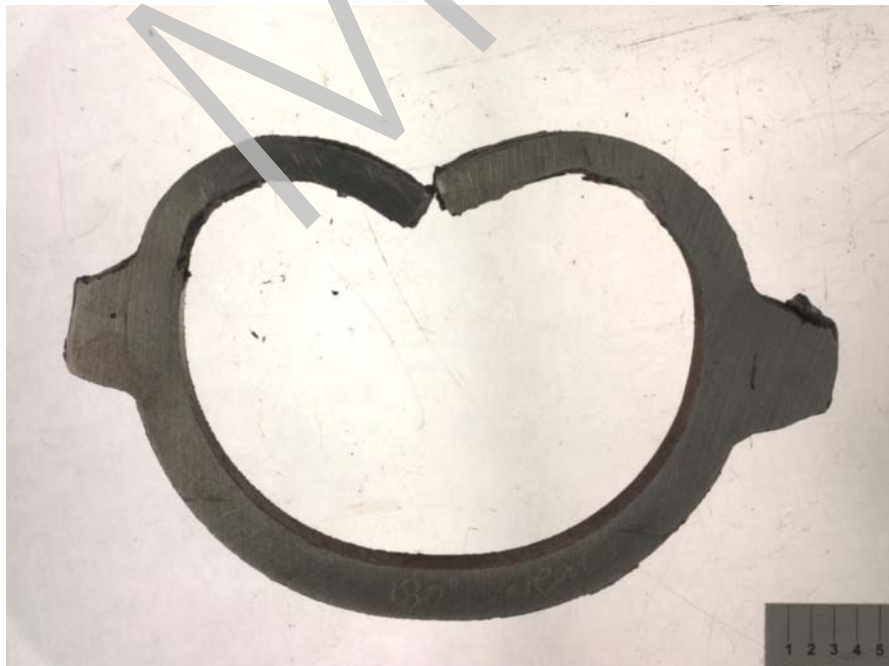
The flattening of the ring section removed produced a fracture through the tube wall on the hot side Figure 12. The microscopic fracture features near the inside surface of the tube consisted of predominantly intergranular fracture with small patches of a dimpled morphology, Figure 13a. These features indicated ductile fracture of the remaining ligaments between the numerous intergranular cracks in the tube wall. The microscopic fracture features near the outer surface were almost entirely dimples indicating a ductile fracture mechanism, Figure 13b.

Figure 12 Ring section removed from tube near through-wall crack - as cut (a) and after flattening (b). The hot side is on the top of the ring in both images.

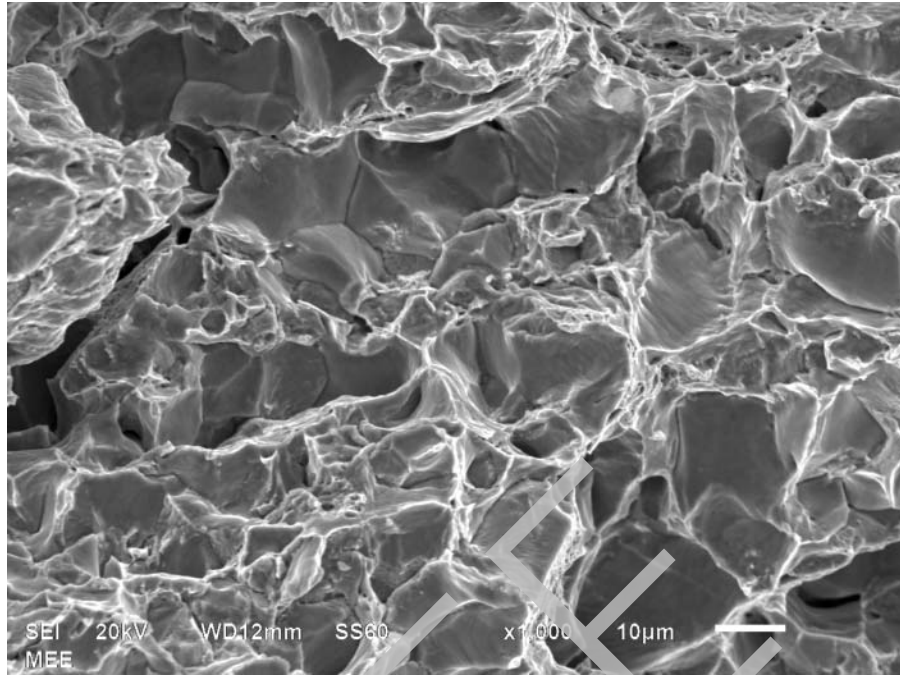
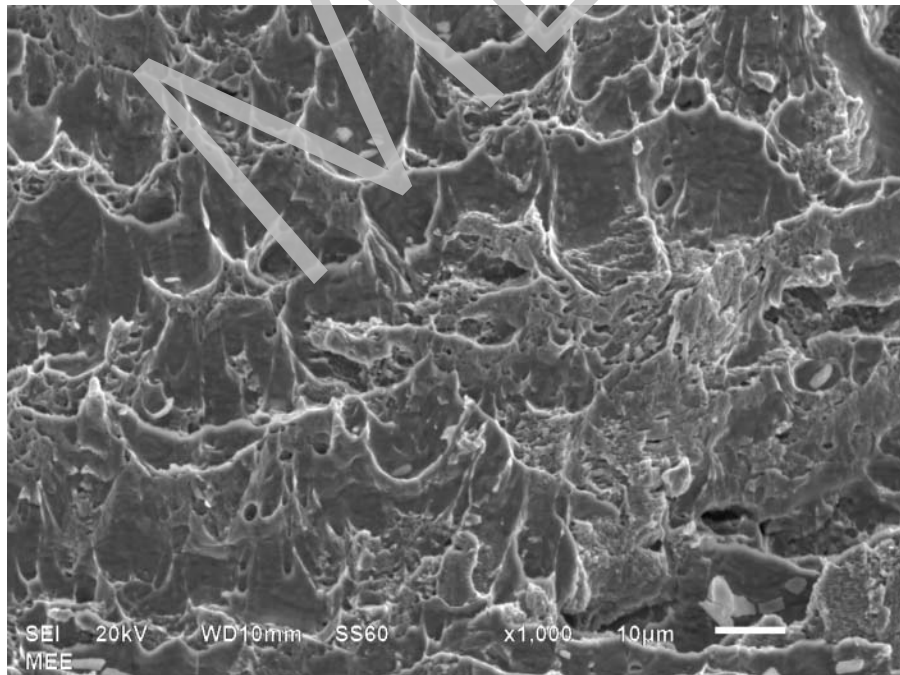
Figure 13 Microscopic features of the laboratory fracture at the indicated locations.

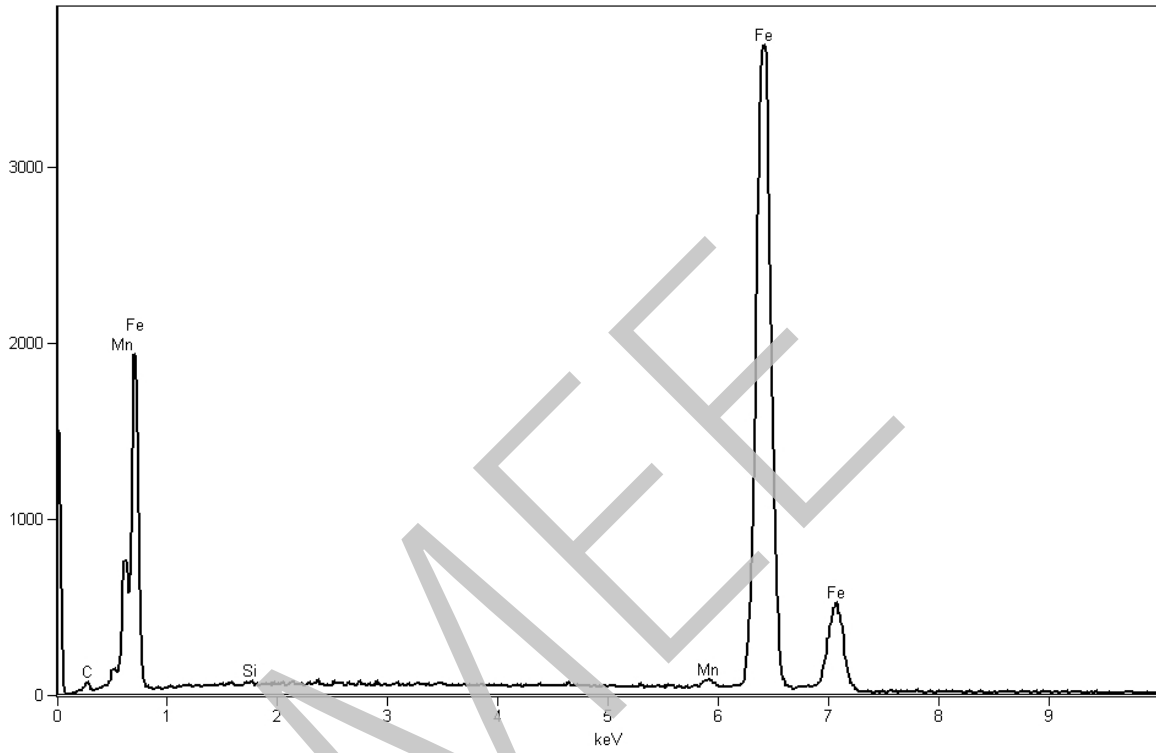
EDS analysis of the fracture surface detected primarily iron, with smaller concentrations of carbon, manganese and silicon, Figure 14. This composition was consistent with a carbon steel tube material.

Figure 14 Spectrum for EDS analysis of the base metal at the laboratory fracture surface.

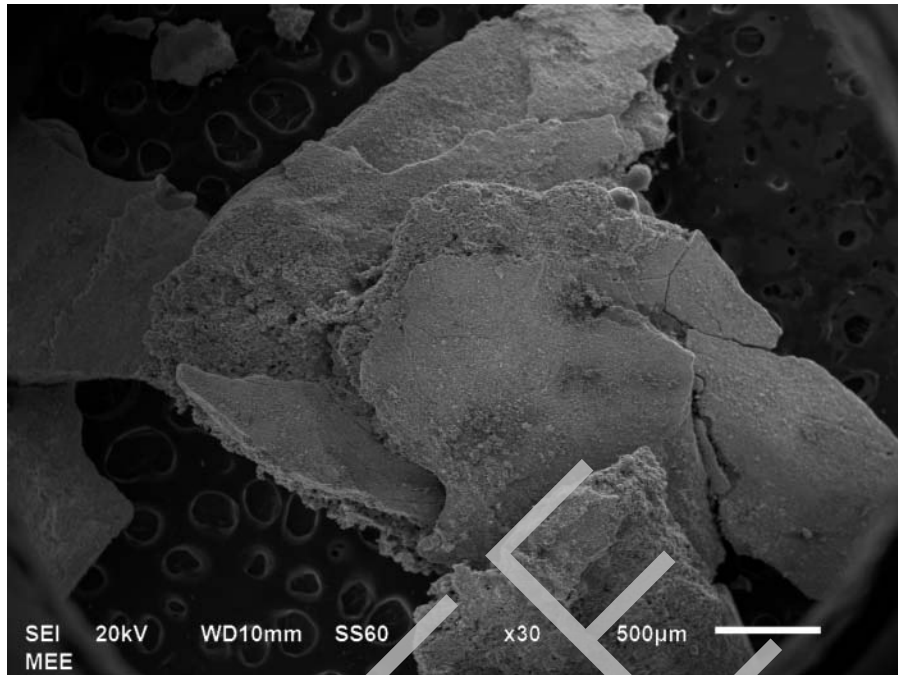
Analysis of nonmetallic material scraped from the inner surface on the hot side near the crack detected primarily iron and oxygen, with lesser concentrations of aluminum, carbon, chromium, copper, nickel, phosphorous and zinc, Figures 15 and 16. Thus, the nonmetallic material was predominantly iron oxide. The remaining elements were likely corrosion products for other areas of the boiler, residue of water treatment chemicals, and water contaminants.

Figure 15 SEM image of the nonmetallic material scraped from the inner surface of the hot side of the tube.

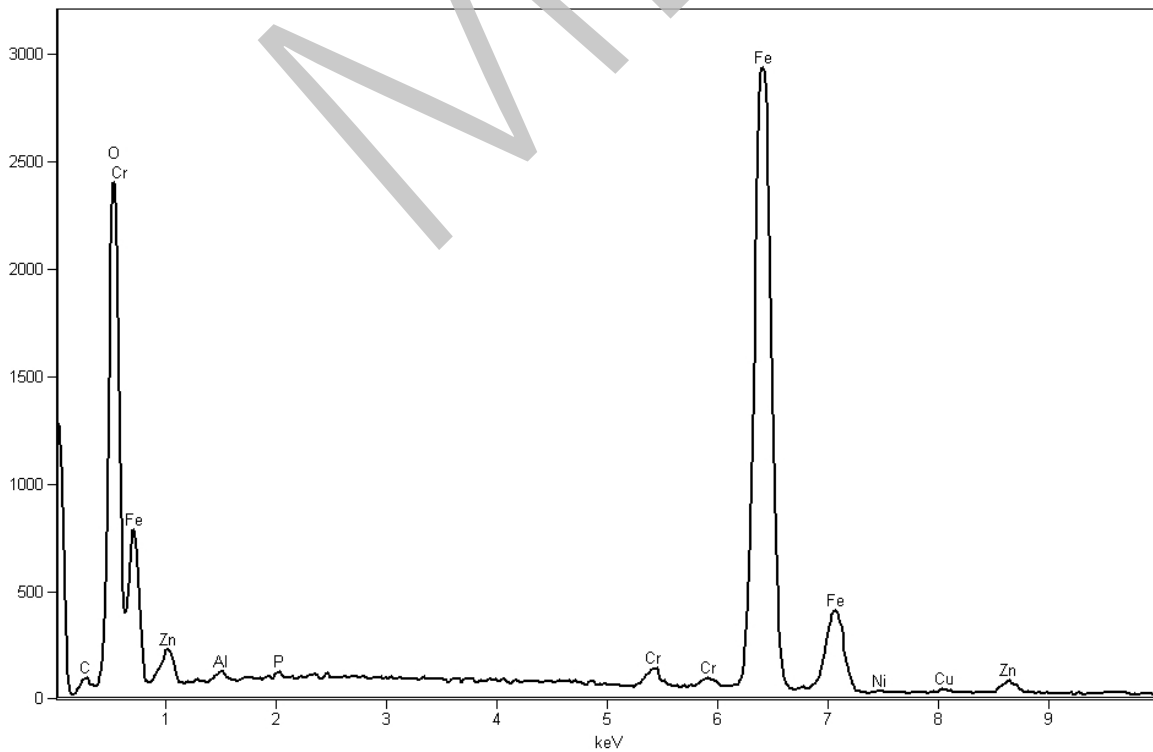
Figure 16 Spectrum for EDS analysis of the material scraped from the inner surface of the hot side of the tube.
